CHALK MINE STABILISATION PROJECT HIGHBARNS, HEMEL HEMPSTEAD

Treatment Area 10: Highbarns and Meadow Road Junction

Report Number: 0013-UA000857-TR-01-TAR-0010

OCTOBER 2015

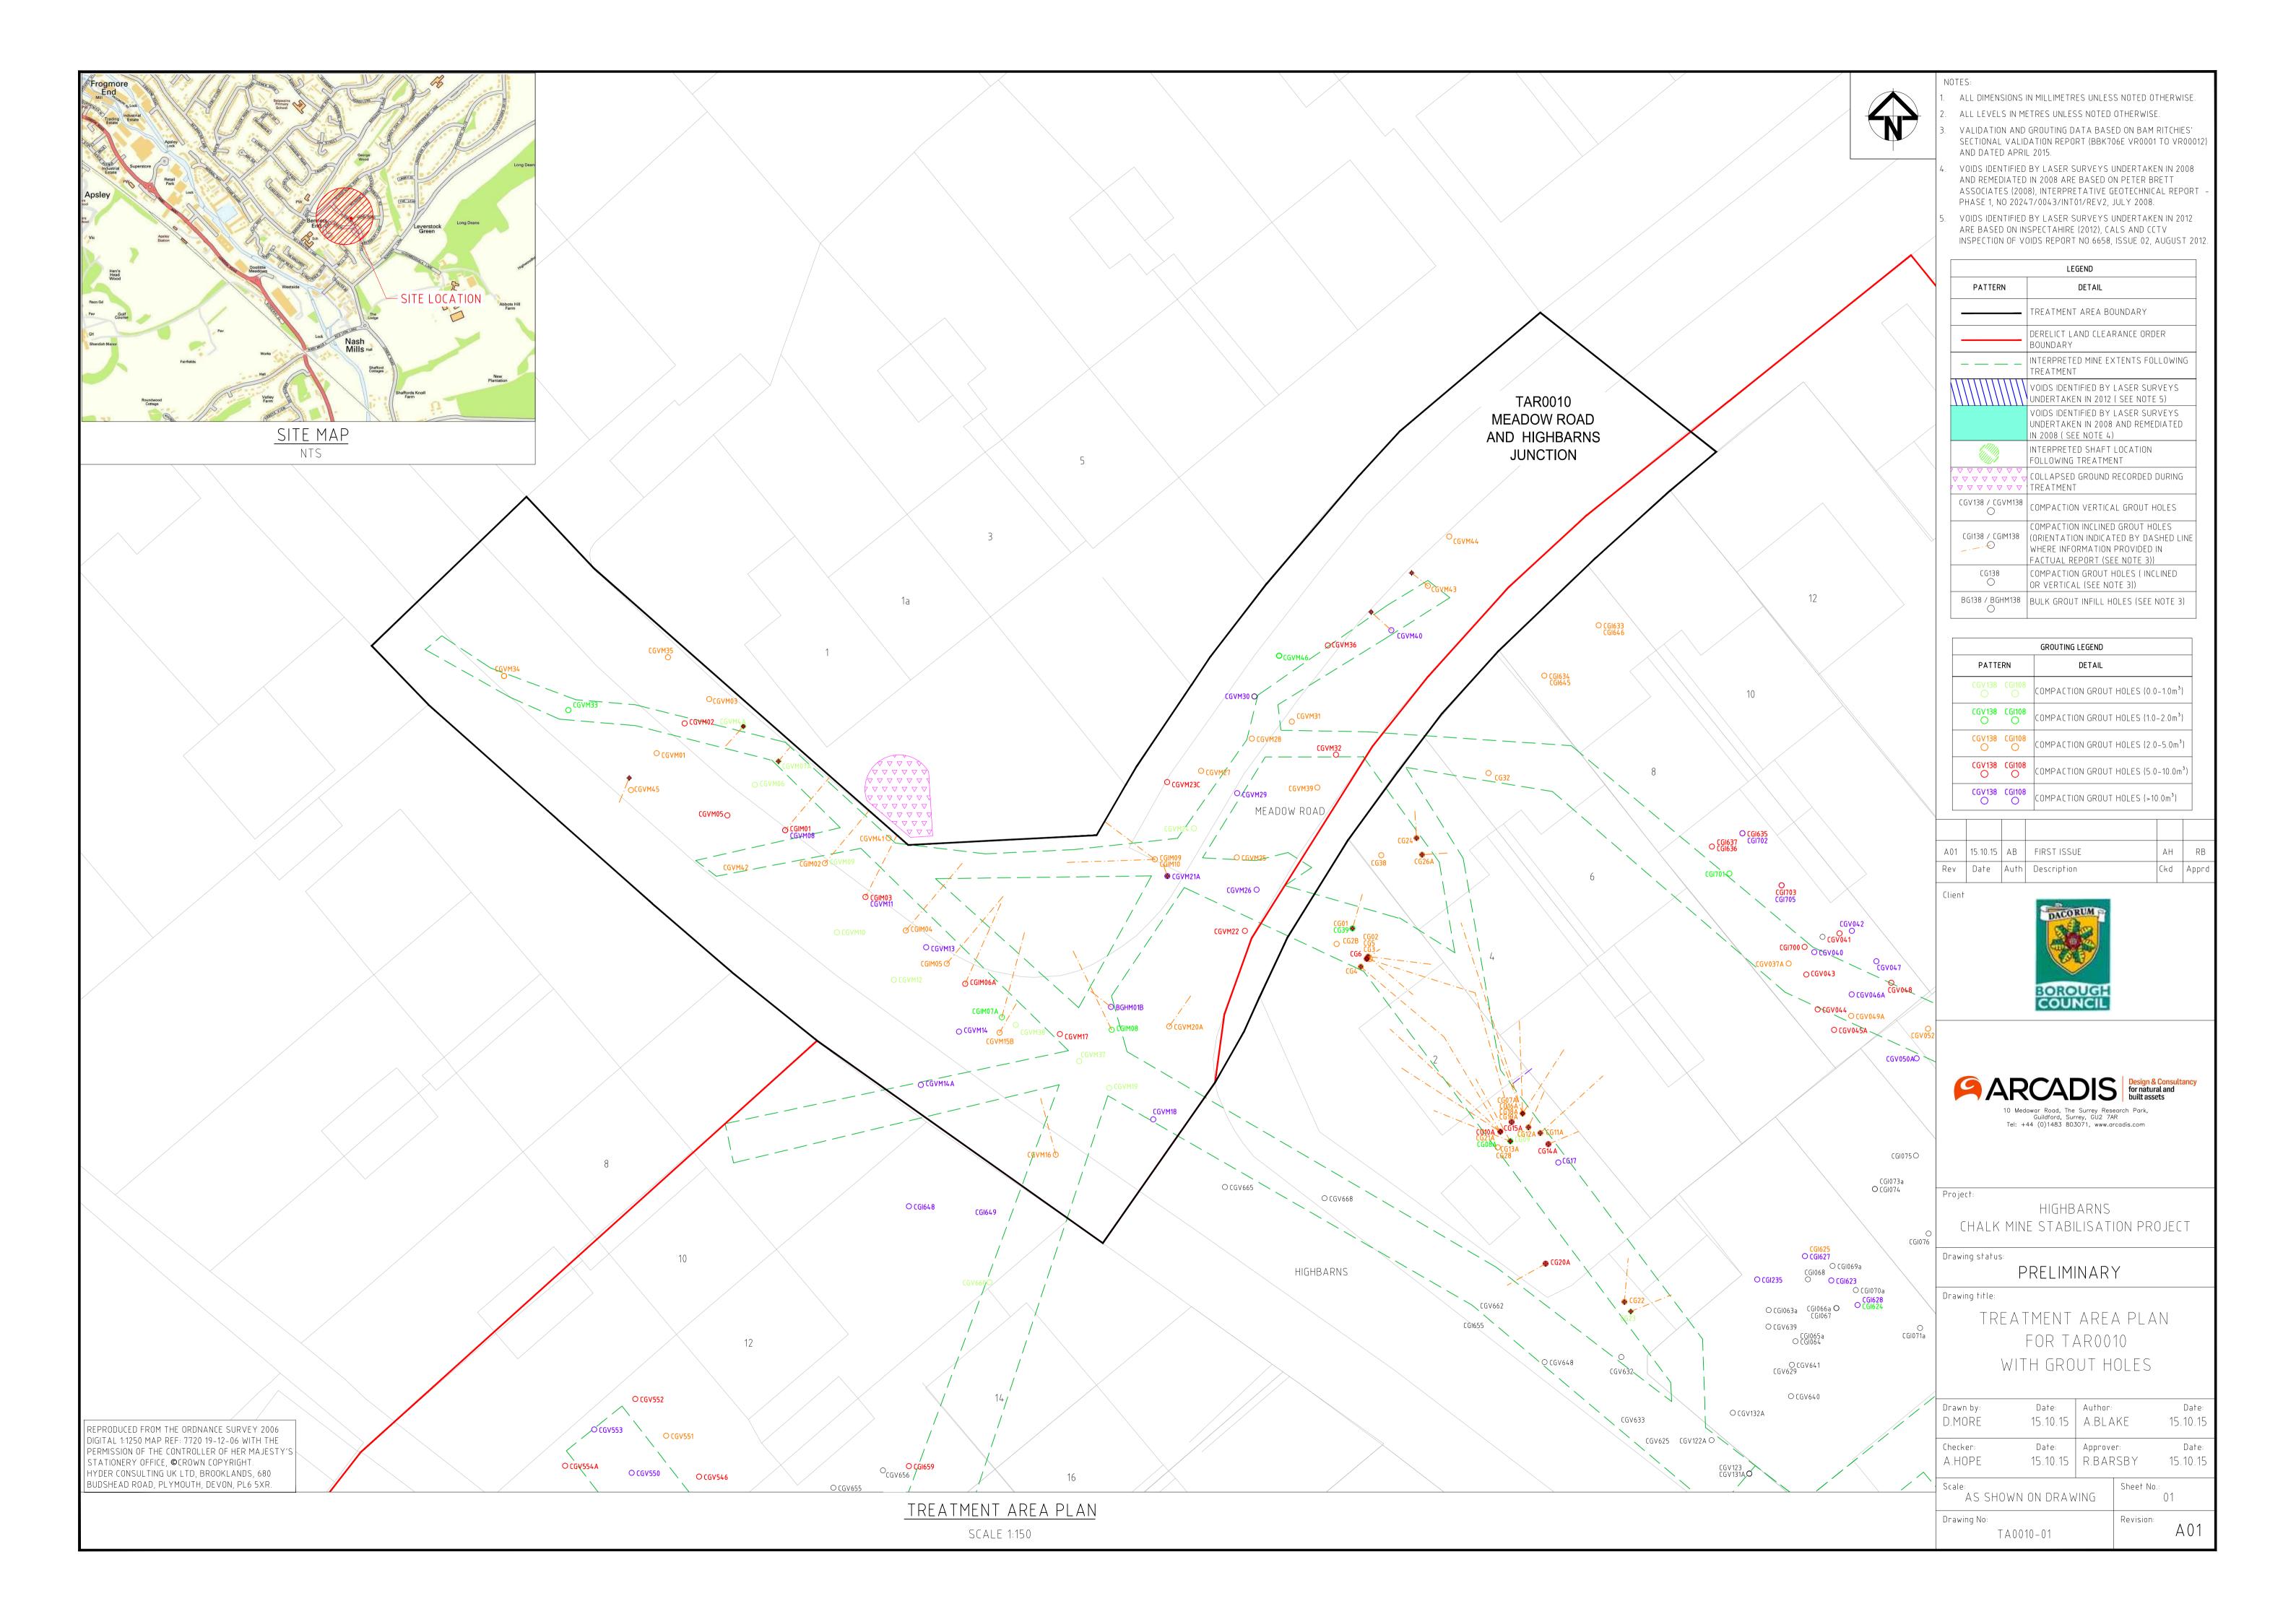
Drawing TA0010-01 – Treatment Area Plan for TAR0010 with Grout Holes

Grouting works were carried out along the line of the interpreted mine workings identified during the investigation stage along Highbarns. High grout takes were recorded in CGVM18 (94m³), BGHM01b (26.3m³) and CGVM14 (83.7m³) located just outside the original DLCO boundary. This indicated that the mine extended beyond the original site boundary and confirmed the need for a continuation of treatment. A consistently high series of grout volumes were observed radiating out from the junction along Highbarns and Meadow Road. These included CGVM8 (12.9m³), CGVM11 (37.7m³) and CGVM13 (24.8m³) extending along Highbarns and CGVM29 (180.11m³) and CGVM30 (14m³) along Meadow Road. The high grout volume at CGVM26 (36.8m³) suggested the possibility of a further mine gallery extending away from the junction towards No. 2 Meadow Road. This confirmed previous areas of poor ground identified by investigation probes MP79 and MP82 (see Treatment Area Report TR0011). Validation probes were completed following treatment and did not identify any residual mining related disturbed ground.

The extent of mined ground in a North West direction along Highbarns was interpreted to terminate due to reduced grout volumes observed at CVGM33 (2.5m³) and CVGM34 (3.6m³). Several rows of dynamic probes along the end of the road did not indicate mine related disturbed ground and suggesting a termination to the mine workings (VPM120 to VPM122).

The extent of mined ground in a North East direction along Meadow Road was interpreted to terminate due to reduced grout volumes observed at CGVM43 (2.5m³) and CGVM44 (3.64m³). Several rows of dynamic probes along the end of the road did not indicate mine related disturbed ground suggesting a termination to the mine workings (VPM210 to VPM220).

Location	Type of Hole	Number of Holes	Range of Grout volumes ¹ (m ³)	Total Grout volume ¹ (m ³)
	Bulk Infilling	1	-	26.3
Highbarns and Meadow Road Junction (Total Grout Holes = 58, Total Grout Volume = 713m ³)	Vertical Compaction Grouting	47	0.27m ³ (CGVM37) to 180.11 m ³ (CGVM29)	664.5
	Inclined Compaction Grouting towards 1 and 1a Meadow Road	10	1.49m³ (CGIM08B) to 9.0m³ (CGIM09A)	48.2

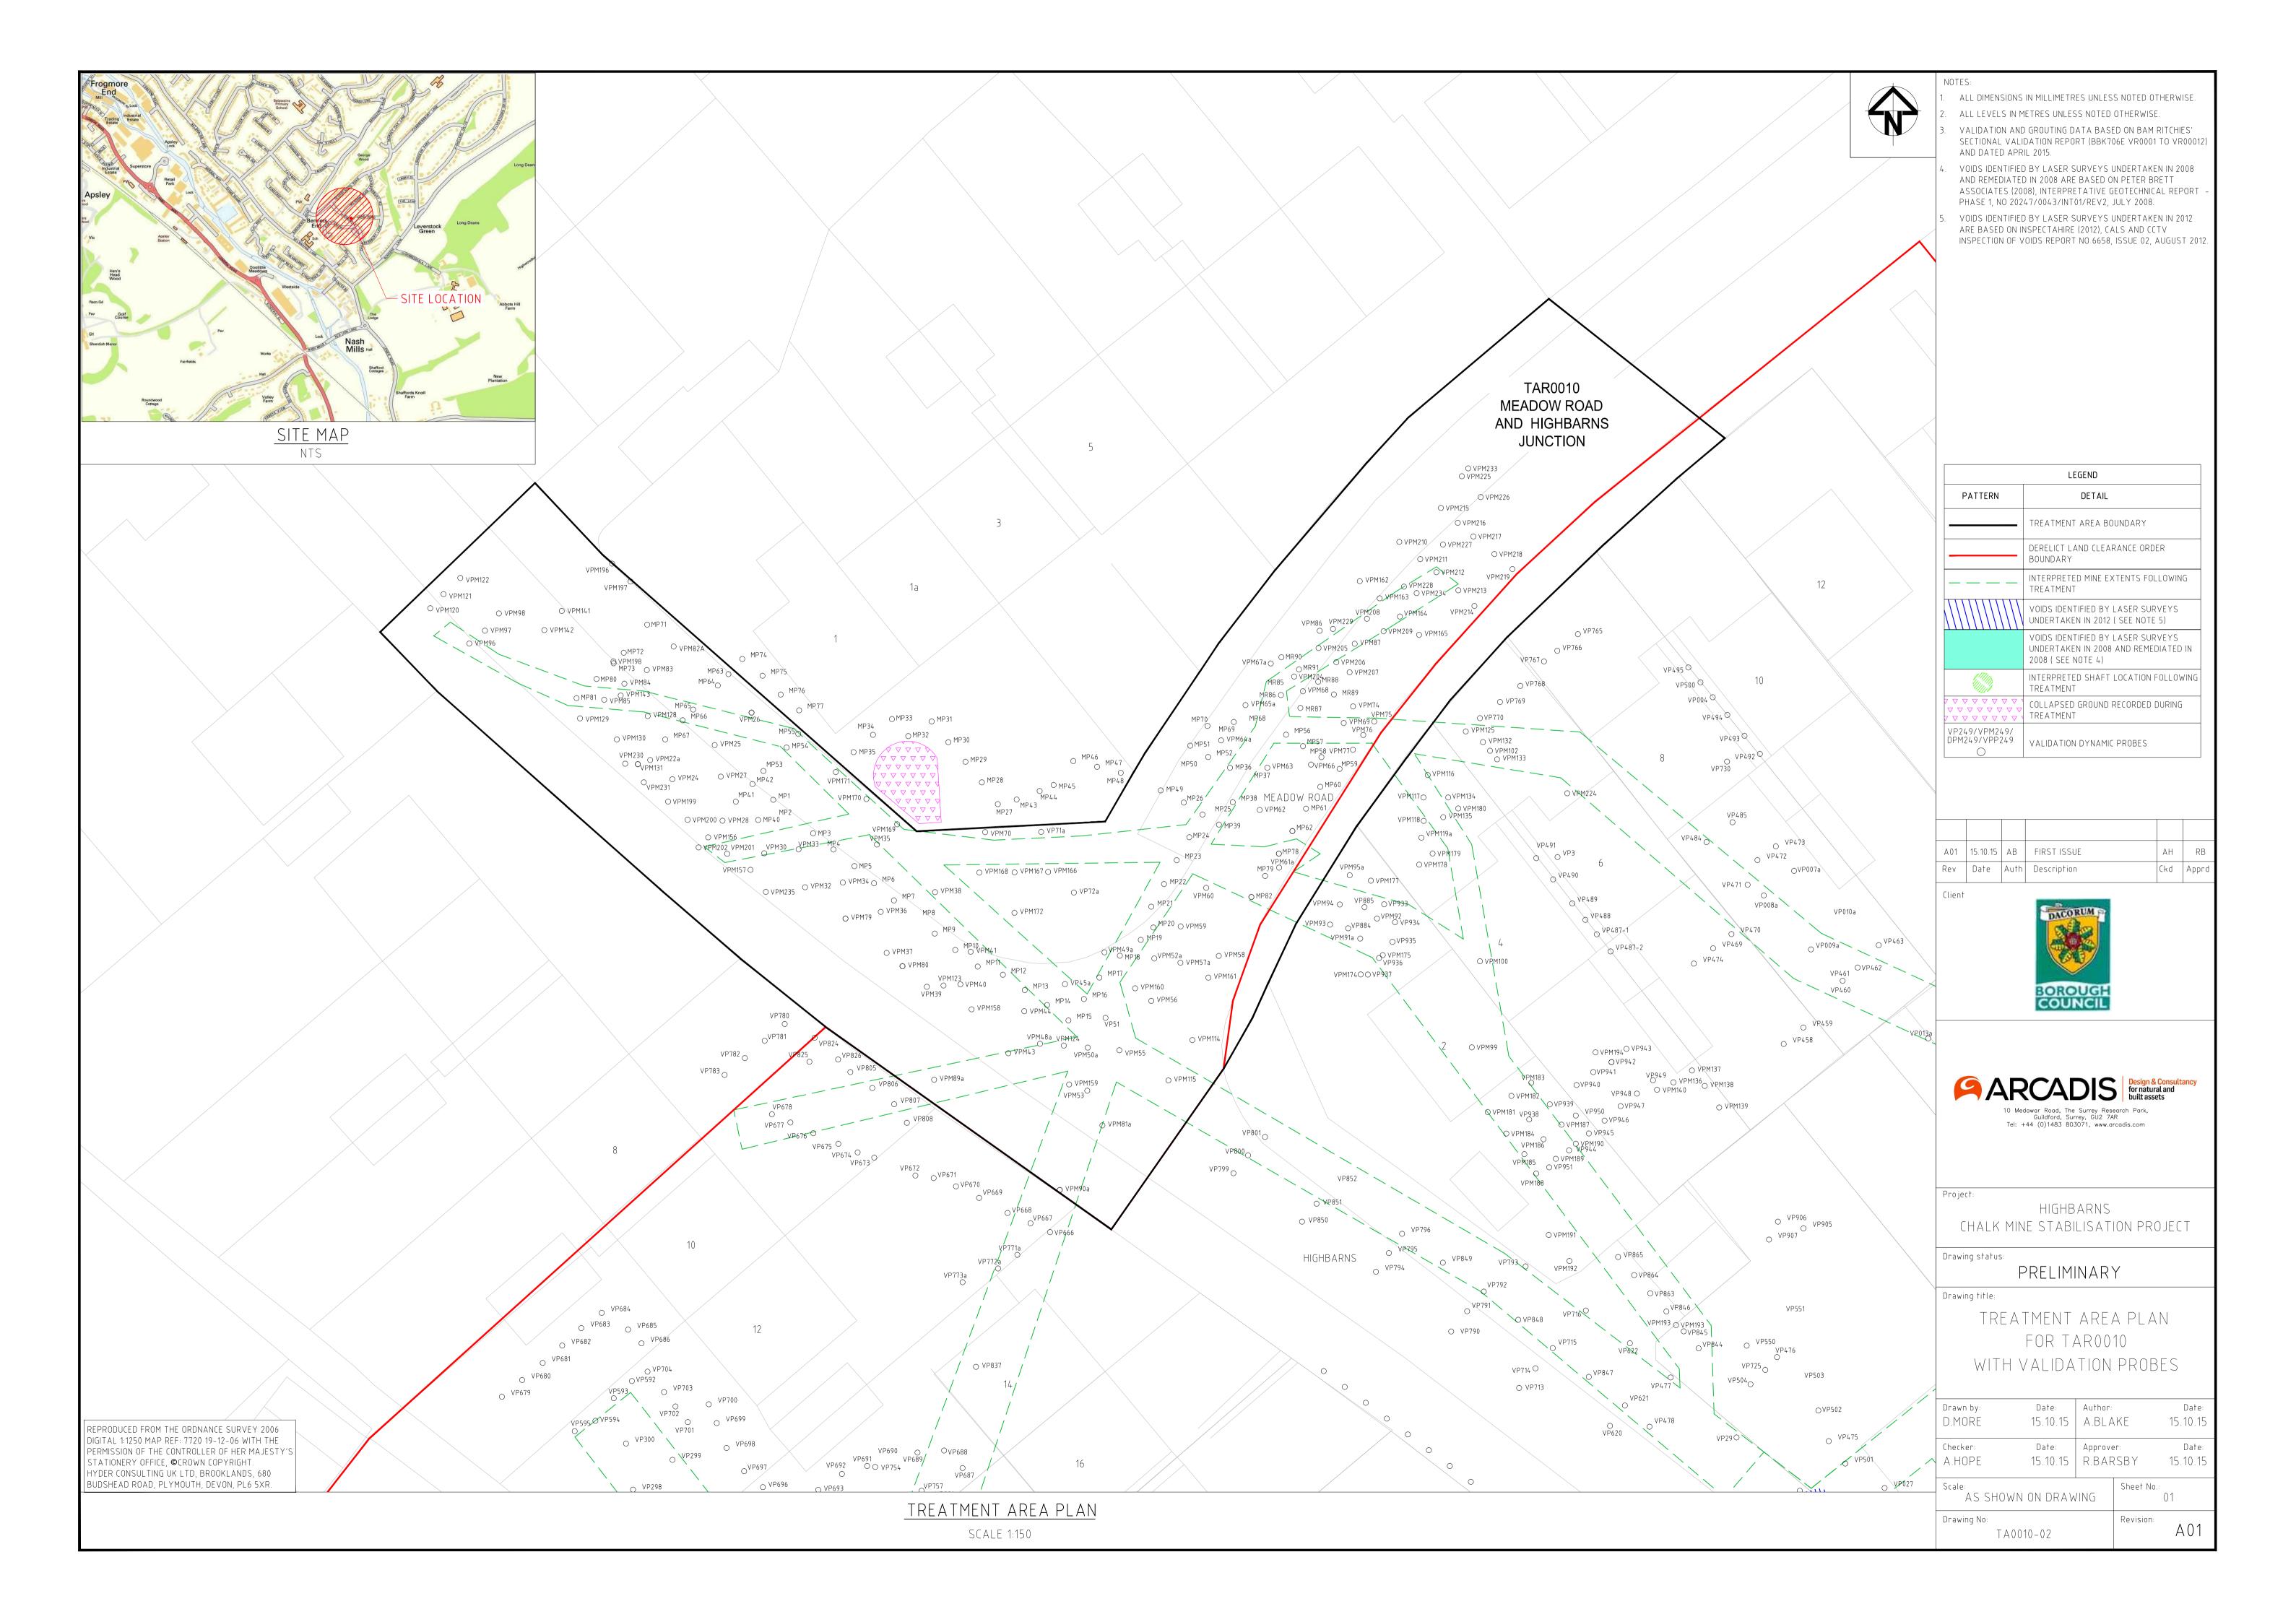
Drawing TA0010-02 – Treatment Area Plan for TAR0010 with Investigative and Validation Probes

An initial row of investigation dynamic probes (denoted MP) were carried out along Highbarns and Meadow Road to identify the extent of potential mine galleries extending from adjacent treatment areas. Evidence of weak ground was identified at various depths in pre-treatment investigative probes such as MP4 (16-17m), MP25 (15-20m) and MP37 (17-20m) suggesting the presence of mine workings extending outside the original DLCO boundary. Several probes also suggested evidence of void migration with poor ground at very shallow depths, such as MP17 where voids were identified near the surface.
