CHALK MINE STABILISATION PROJECT HIGHBARNNS, HEMEL HEMPSTEAD

Treatment Area 8: Nos. 28, 29 & 30 East Green

Report Number: 0013-UA000857-TR-01-TAR-0008

OCTOBER 2015

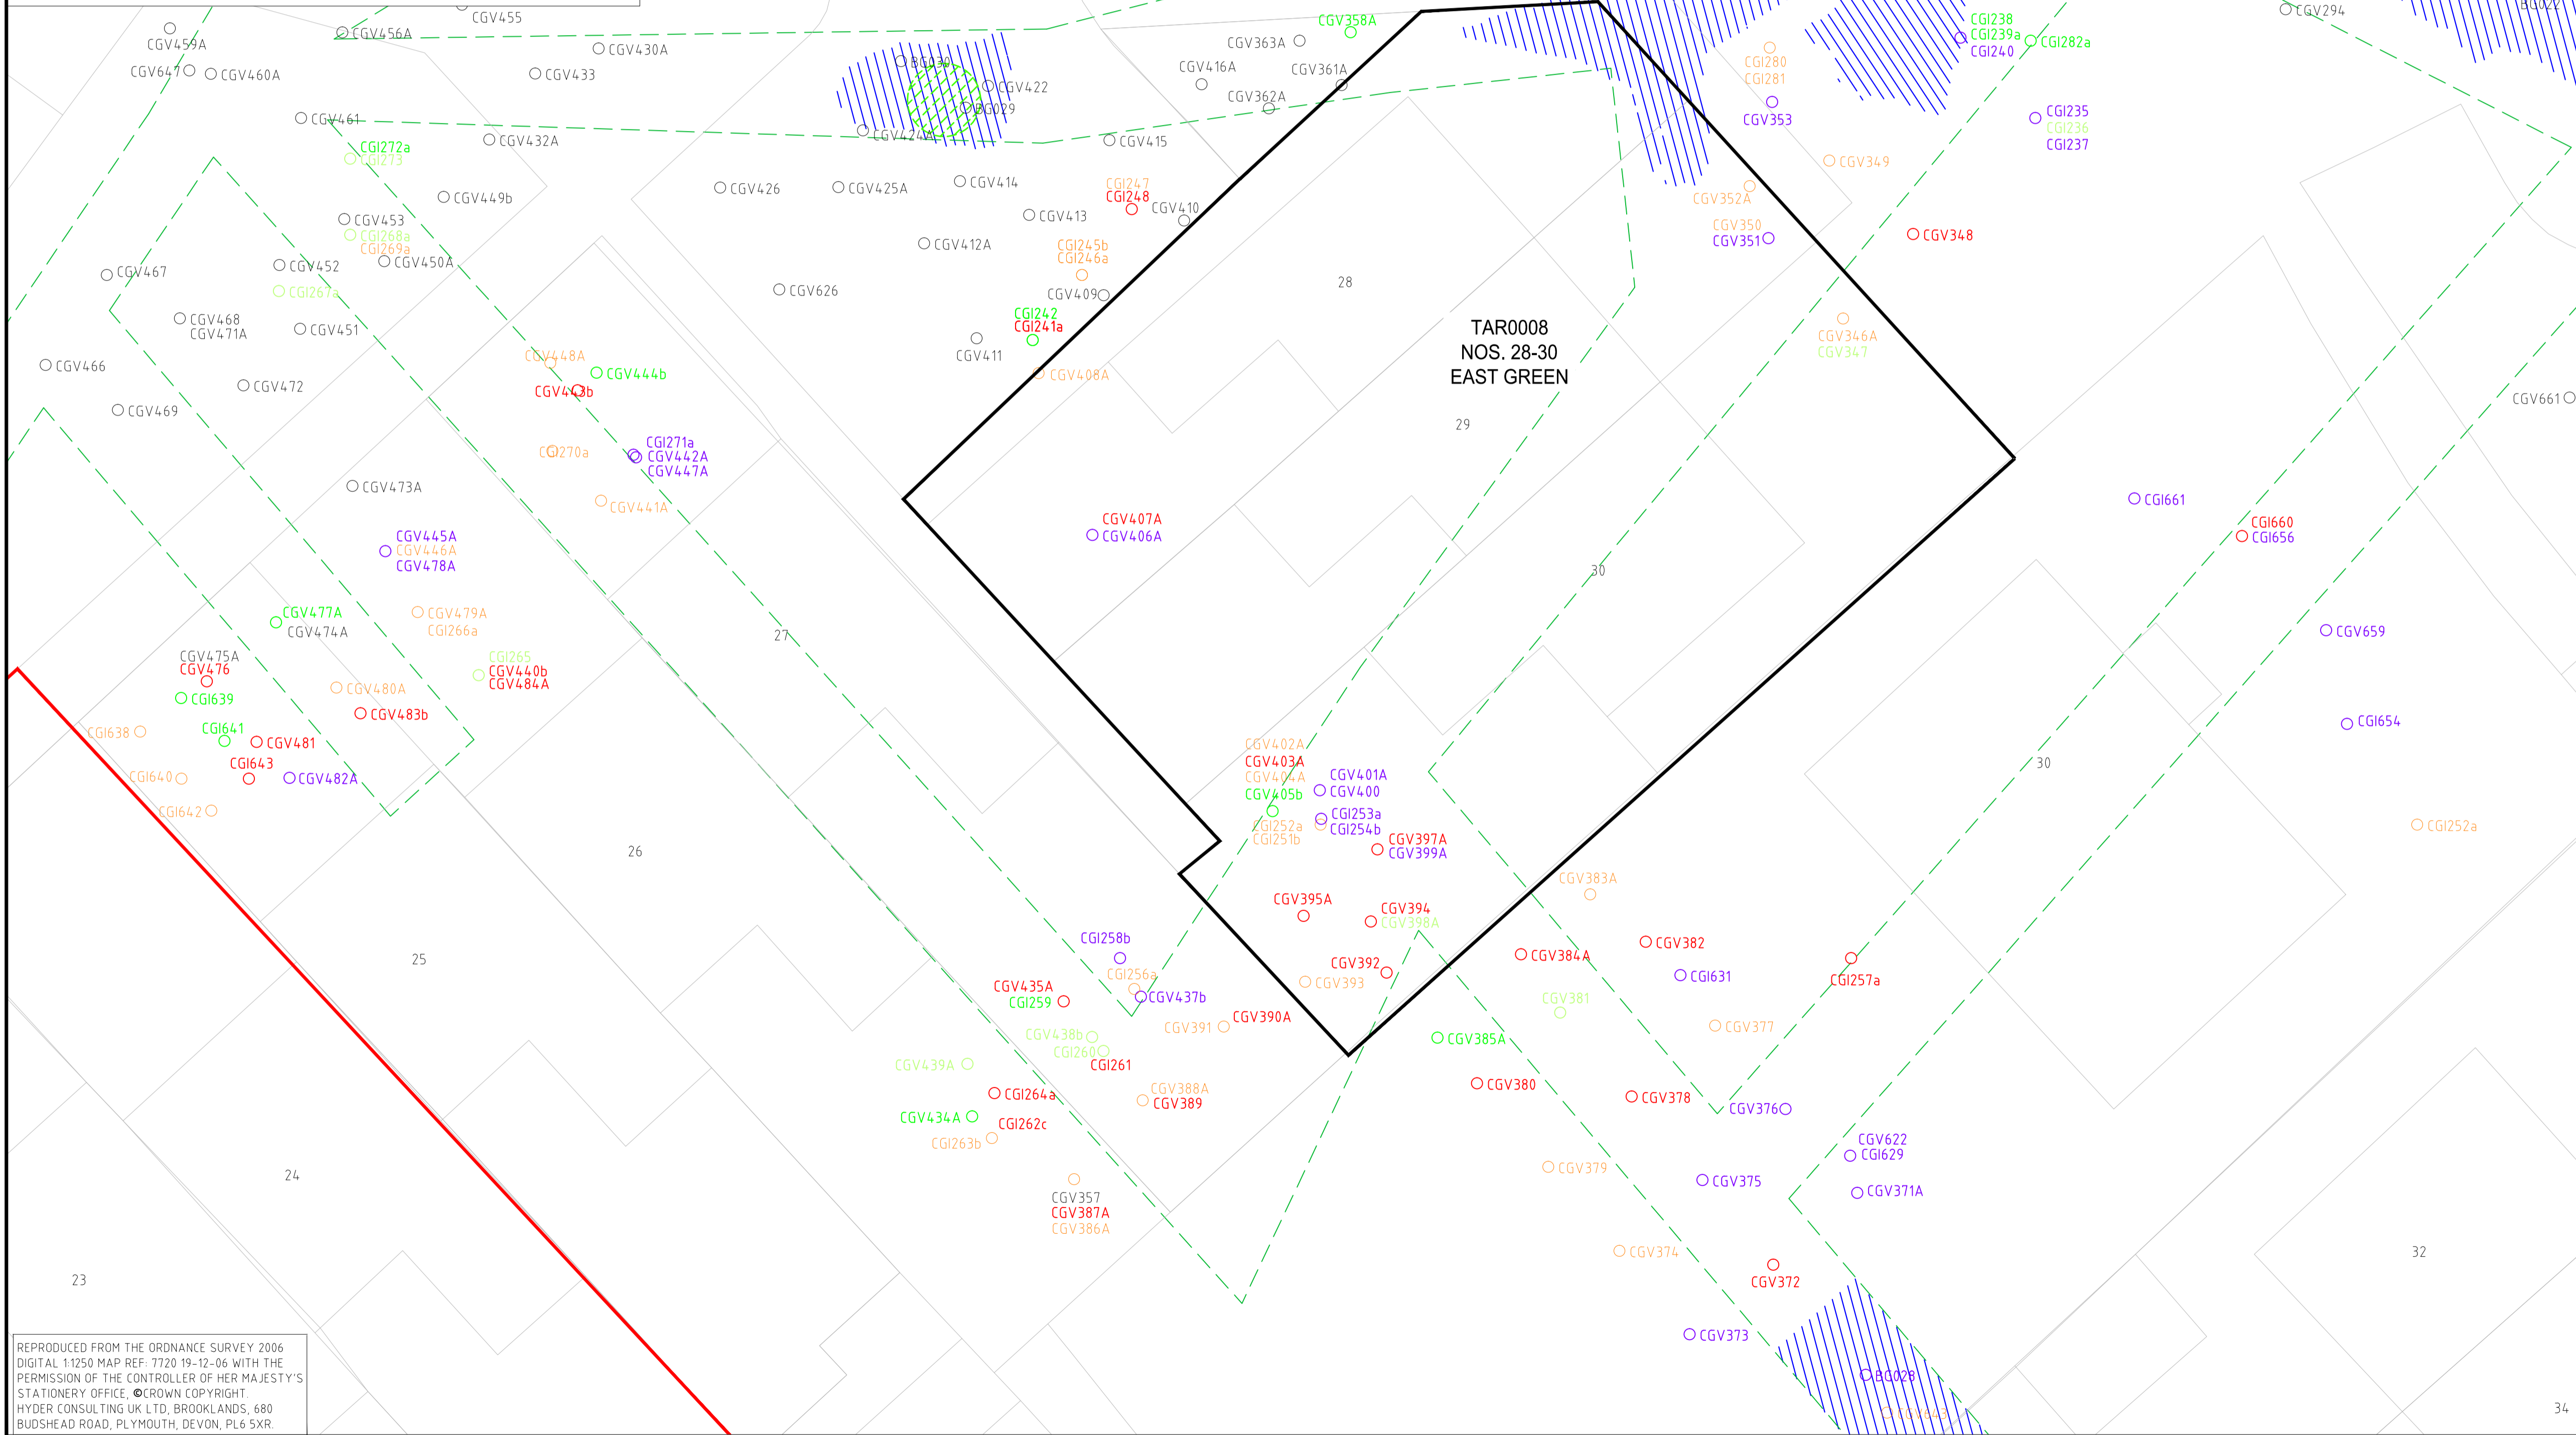
Drawing title: TREATMENT AREA PLAN FOR TAR0008 WITH GROUT HOLES

Treatment works carried out at No. 28 East Green were designed to treat mined ground uncovered following pre-treatment investigation works. Three high grout takes along the back garden at CGV406 (23.4m³), CGV407 (8.8m³) and CGV408 (3.4m³) suggested further mine workings outside the original extents. Inclined grout holes (CGI241 –CGI246) originally designed to treat the property from the back garden were drilled from an adjacent open space due to access constraints. These grout volumes suggested generally collapsed mine workings with the volumes injected decreasing as treatment works progressed along the back garden. Grouting works carried out from the front of the property resulted in typically average grout volumes, despite the presence of known voids uncovered prior to treatment works close to the front of the property, indicating successful treatment.

Pre-treatment investigation works carried out at No. 29 East Green identified the presence of mine workings extending under the property before converging at a suspected mine junction located along the front garden where the presence of open voids were identified. High grout volumes at CGI238 (30.9m³) and CGI240 (20.4m³), confirmed the presence of open voids in the area and further high grout volumes were recorded along the front of the property in the area of the anticipated mine junction. A general reduction in grout volumes was noted in successive grout holes drilled along the back garden and beneath the property. Grouting under the house was made possible only from inclined holes drilled in the back garden of the adjacent property No. 30 East Green.

Vertical compaction grout holes carried out along the back garden resulted with high grout volumes at CGV399 (15.4m³) and CGV401 (43.4m³) suggestive of open mine workings at the mine junction. A gradual reduction in grout volumes was observed at the remaining treatment locations in the back garden. Further inclined grout holes were also undertaken beneath the property from the back garden. Following the initial high grout takes at CGI253 (20.1m³) and CGI254 (12.4m³), subsequent grout volumes were seen to reduce to site-wide average grout takes at CGI251 (3.1m³) and CGI252 (4.4m³).

Treatment along the back garden resulted in a high grout take at CGV401 (43.4m³) which was assumed to be located within the mine junction. Following this grout hole, generally consistent minimal grout volumes were recorded.

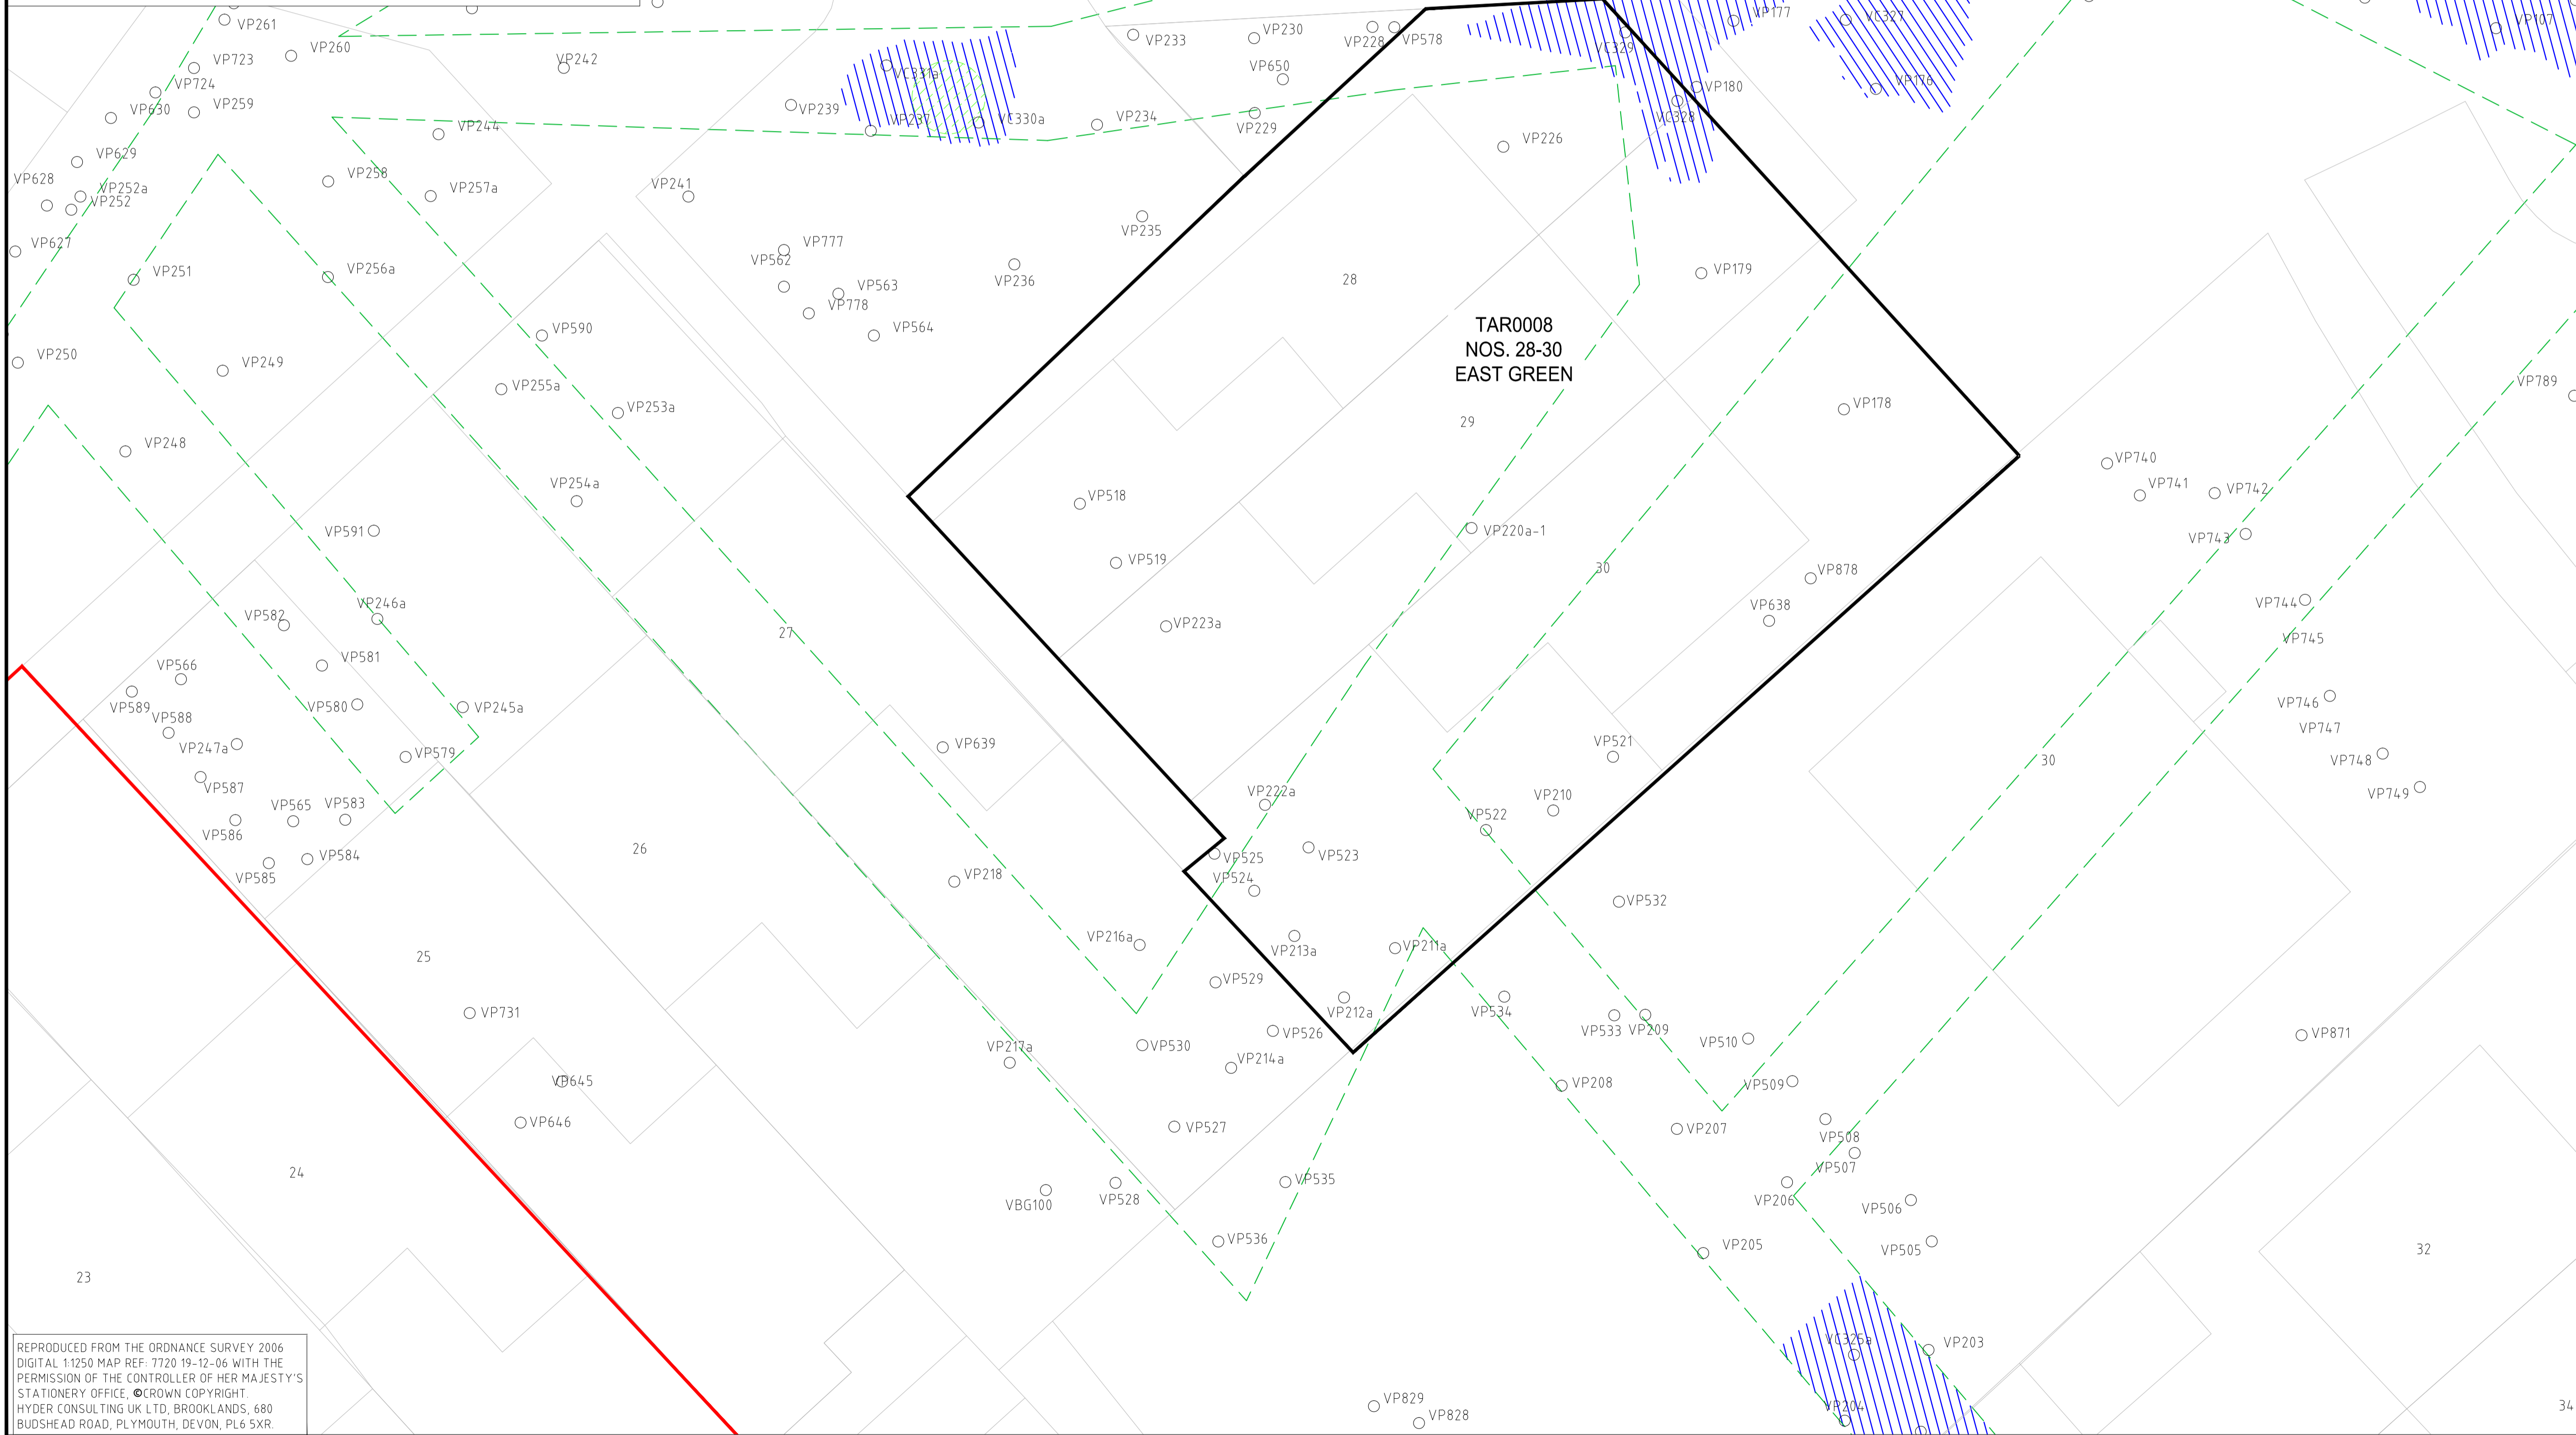
Drawing title: TREATMENT AREA PLAN FOR TAR0008 WITH VALIDATION PROBES

Validation probing carried out along the front and back gardens following grouting works revealed more competent ground conditions than pre-treatment. A total volume of 56.2m³ of grout was injected into ten vertical and inclined compaction grout holes targeted at this property.

The validation dynamic probe (VP229) carried out inside the building following treatment did not record any residual weaknesses in the chalk. Likewise validation probing carried out in front of the property with VP179 revealed competent ground conditions following treatment.

Several validation dynamic probes were carried out along the back garden and side of No. 30 East Green to determine the termination of mine-related disturbed ground in the area. The results confirmed competent treatment of the area, suggesting the scope of works designed had been adequate to treat the extent of interpreted mine workings.
