# HIGHBARNS – HEMEL HEMPSTEAD

Dr Clive Edmonds – Partner  
Stuart Chandler – Associate

# INTRODUCTION

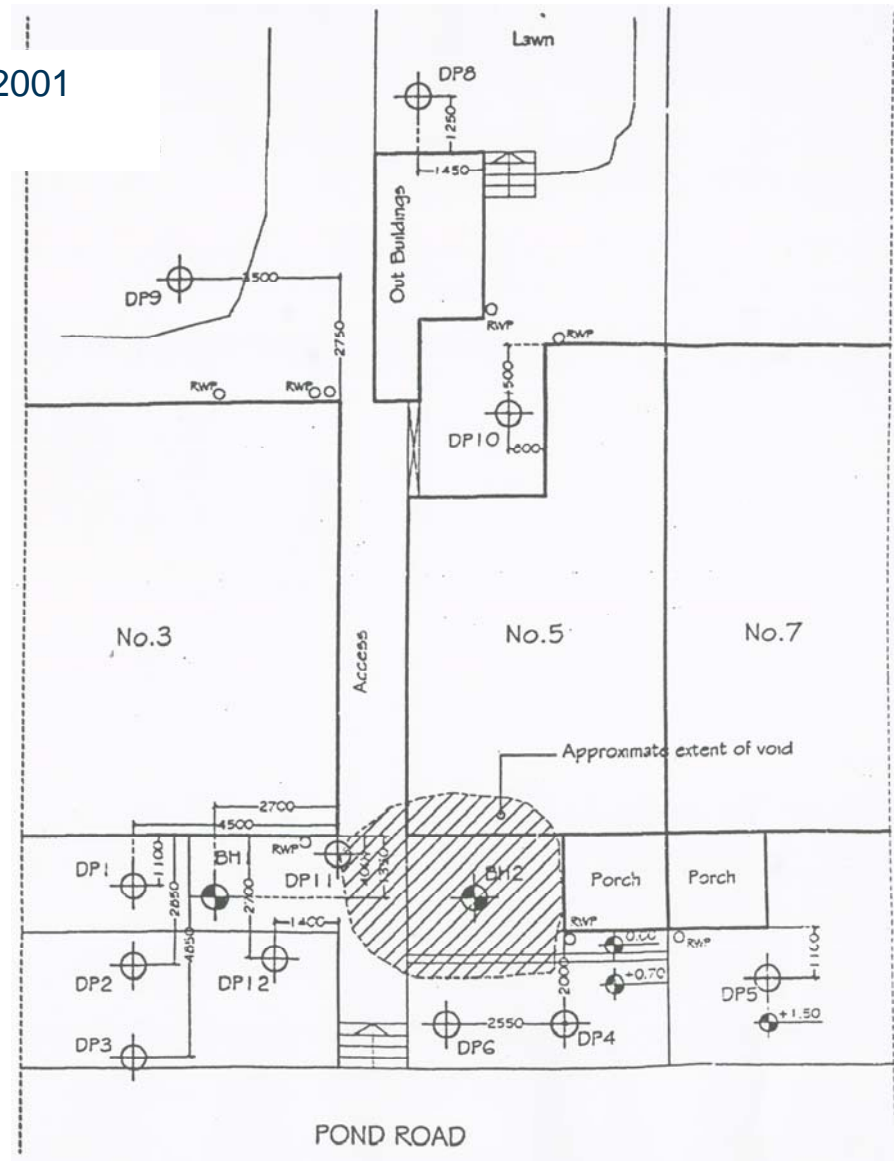
- FAILURE AT NO. 5 POND ROAD IN NOVEMBER 2001
- STABILISED BY GROUTING IN MAY 2003

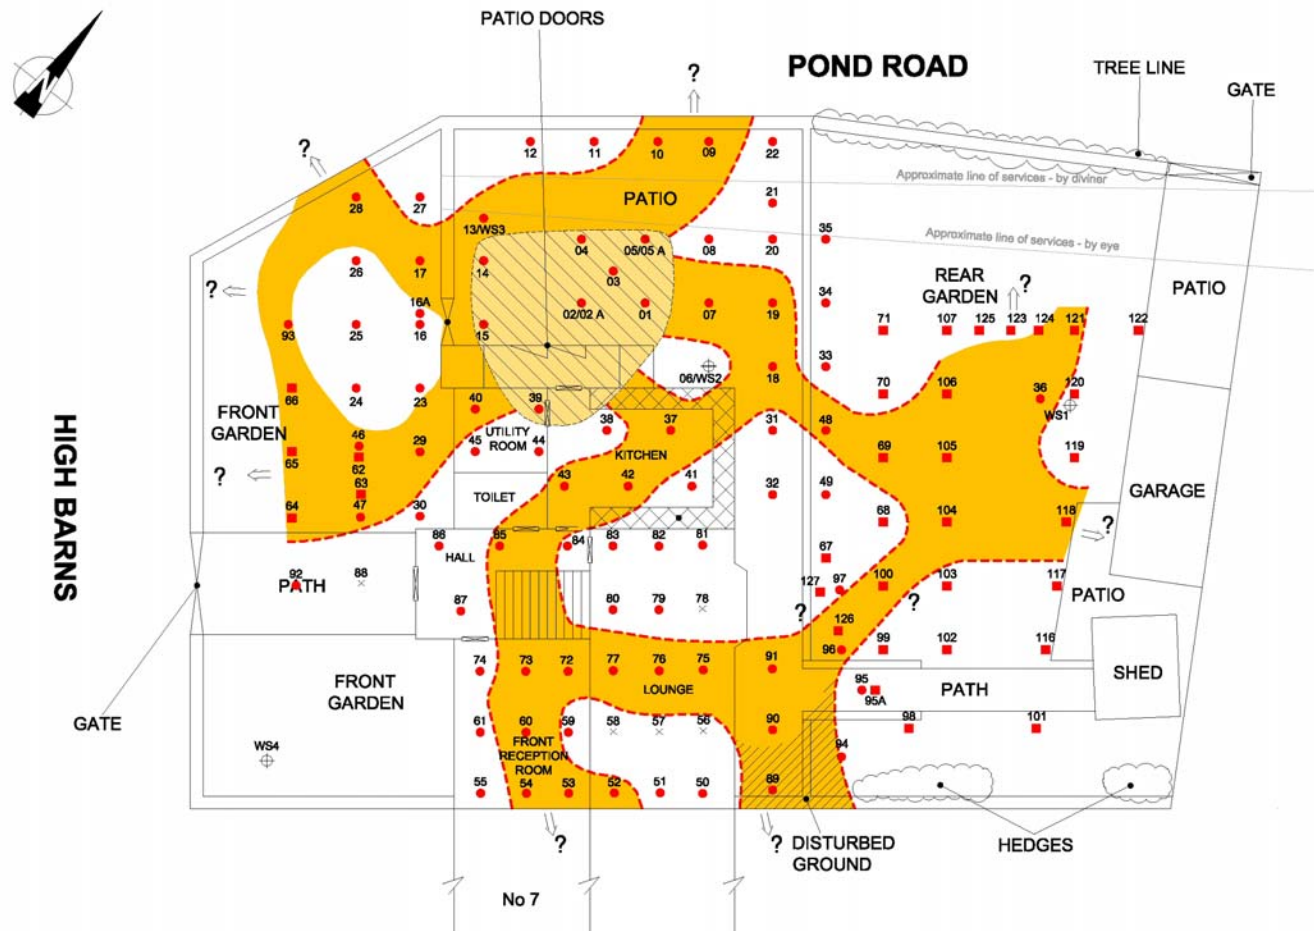
- FAILURE AT NO. 5 Highbarns in June 2007
- INVESTIGATION THROUGH June 2007 to March 2008
- STABILISATION WORKS FROM 4<sup>TH</sup> August 2008 to 17<sup>TH</sup> October 2008

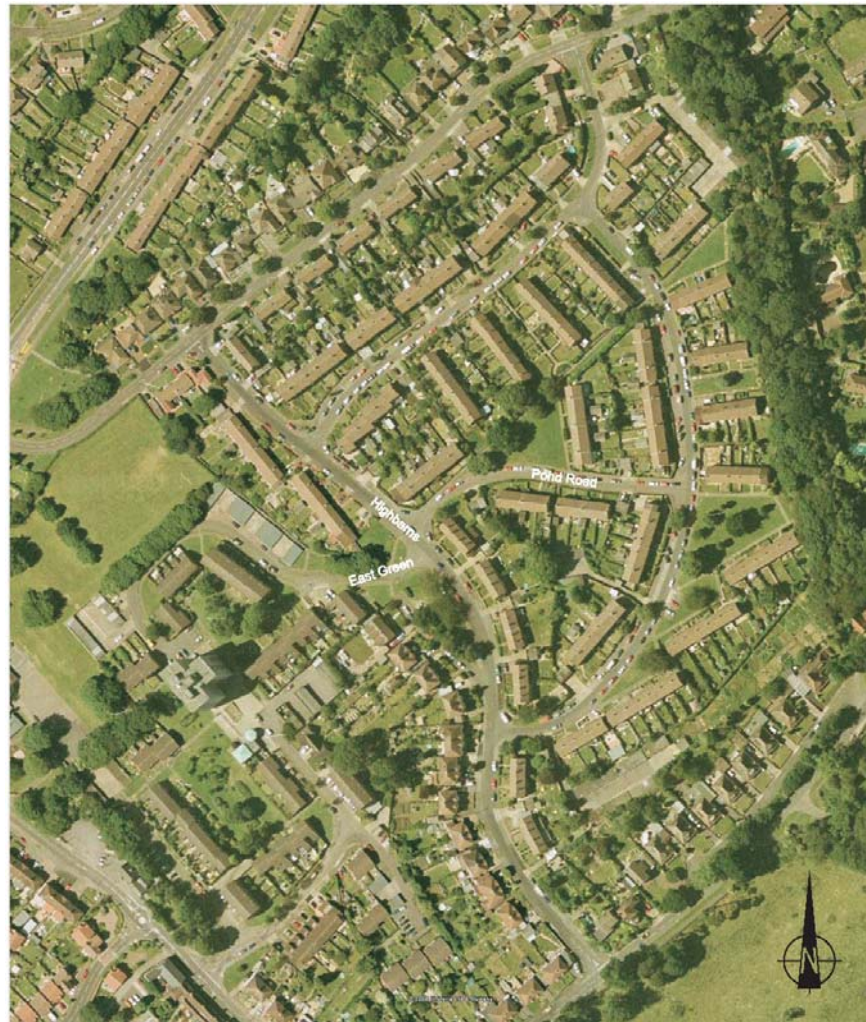
- INVESTIGATIONS PROPOSED AROUND POND ROAD/HIGHBARNNS/EAST GREEN JUNCTION

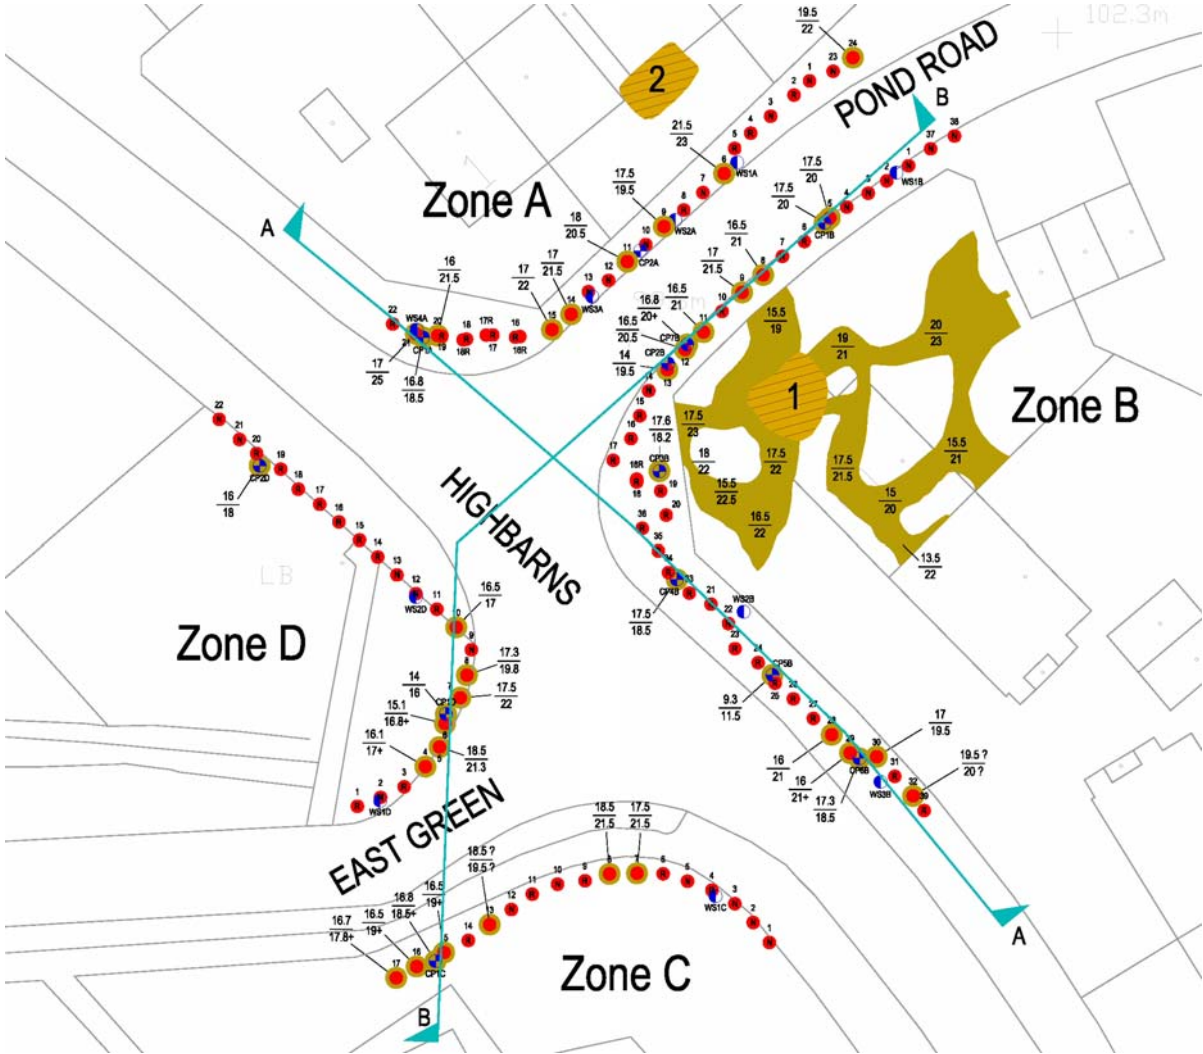
## INTRUSIVE INVESTIGATIONS LEAD TO DEVELOPMENT OF INITIAL INTERPRETIVE PLAN

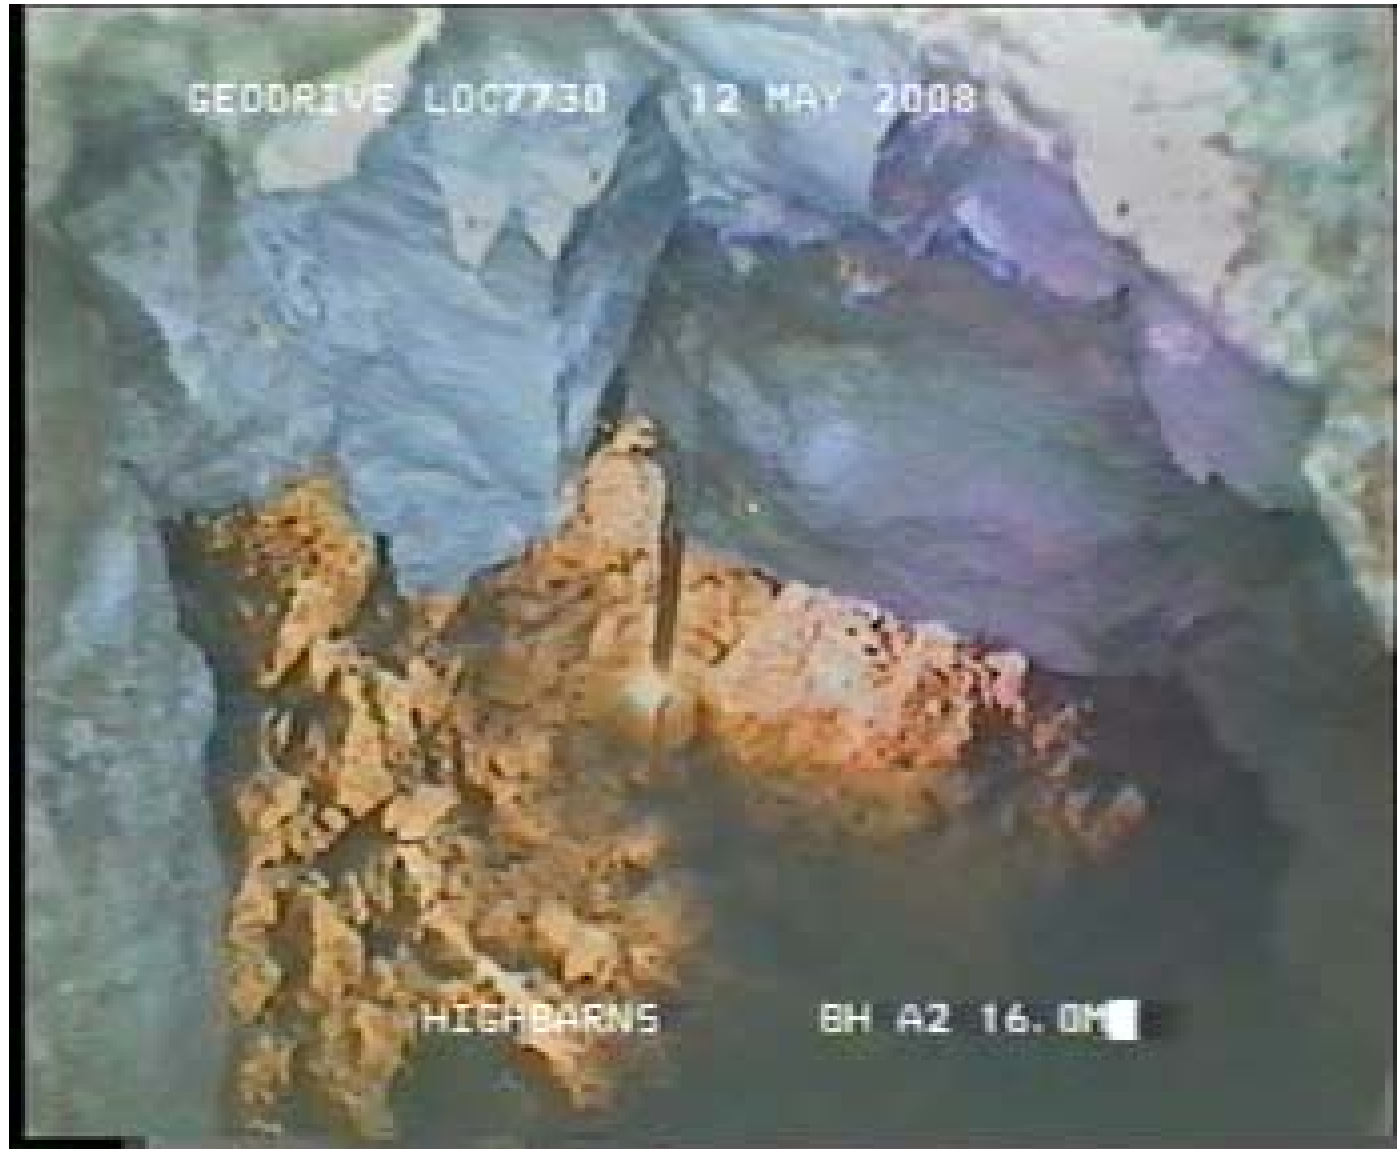
# CCTV SURVEY AT BOREHOLE CP1A

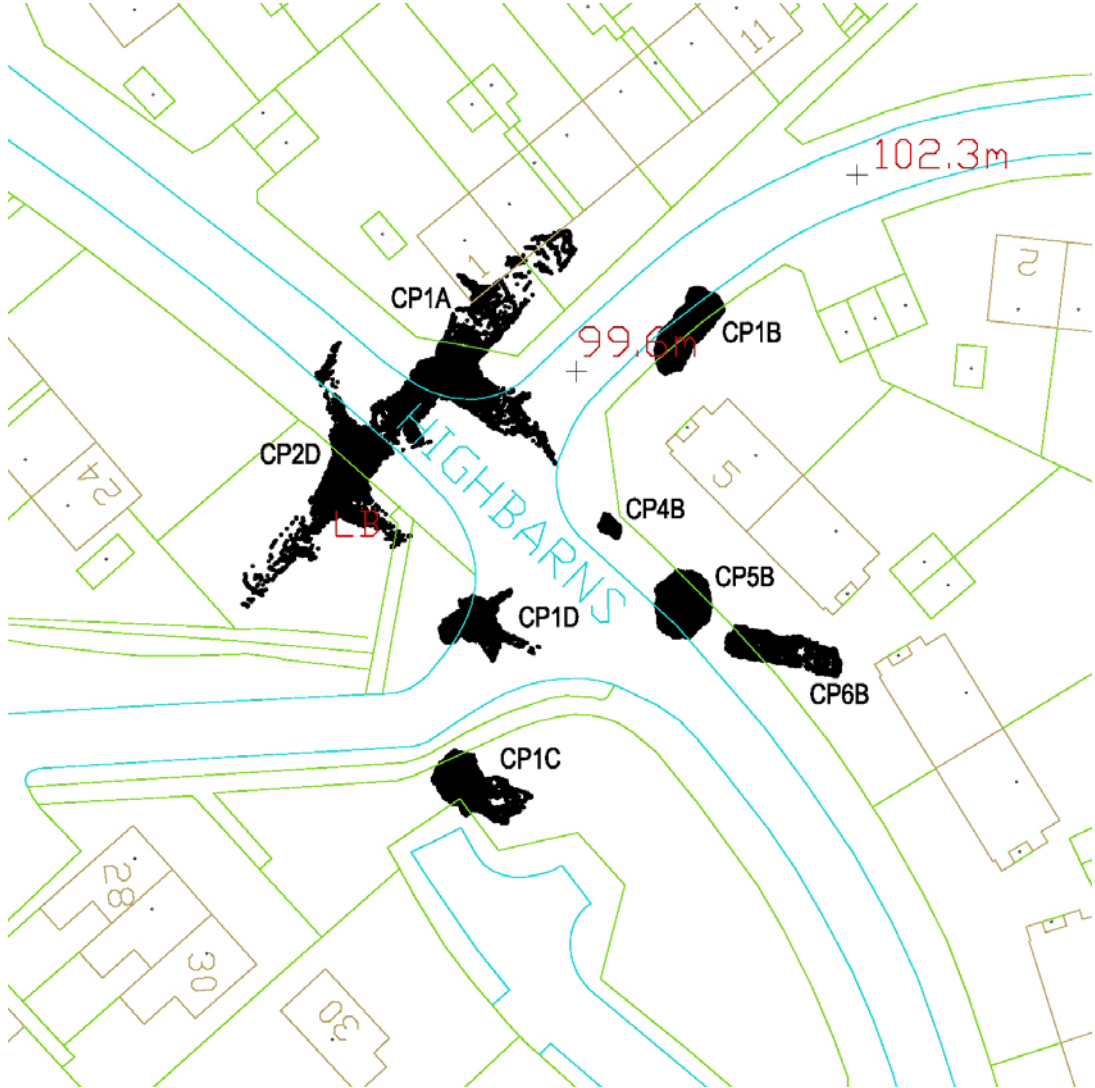
EARLY RESULTS PROMOTED APPLICATION OF LASER SURVEY TECHNIQUES

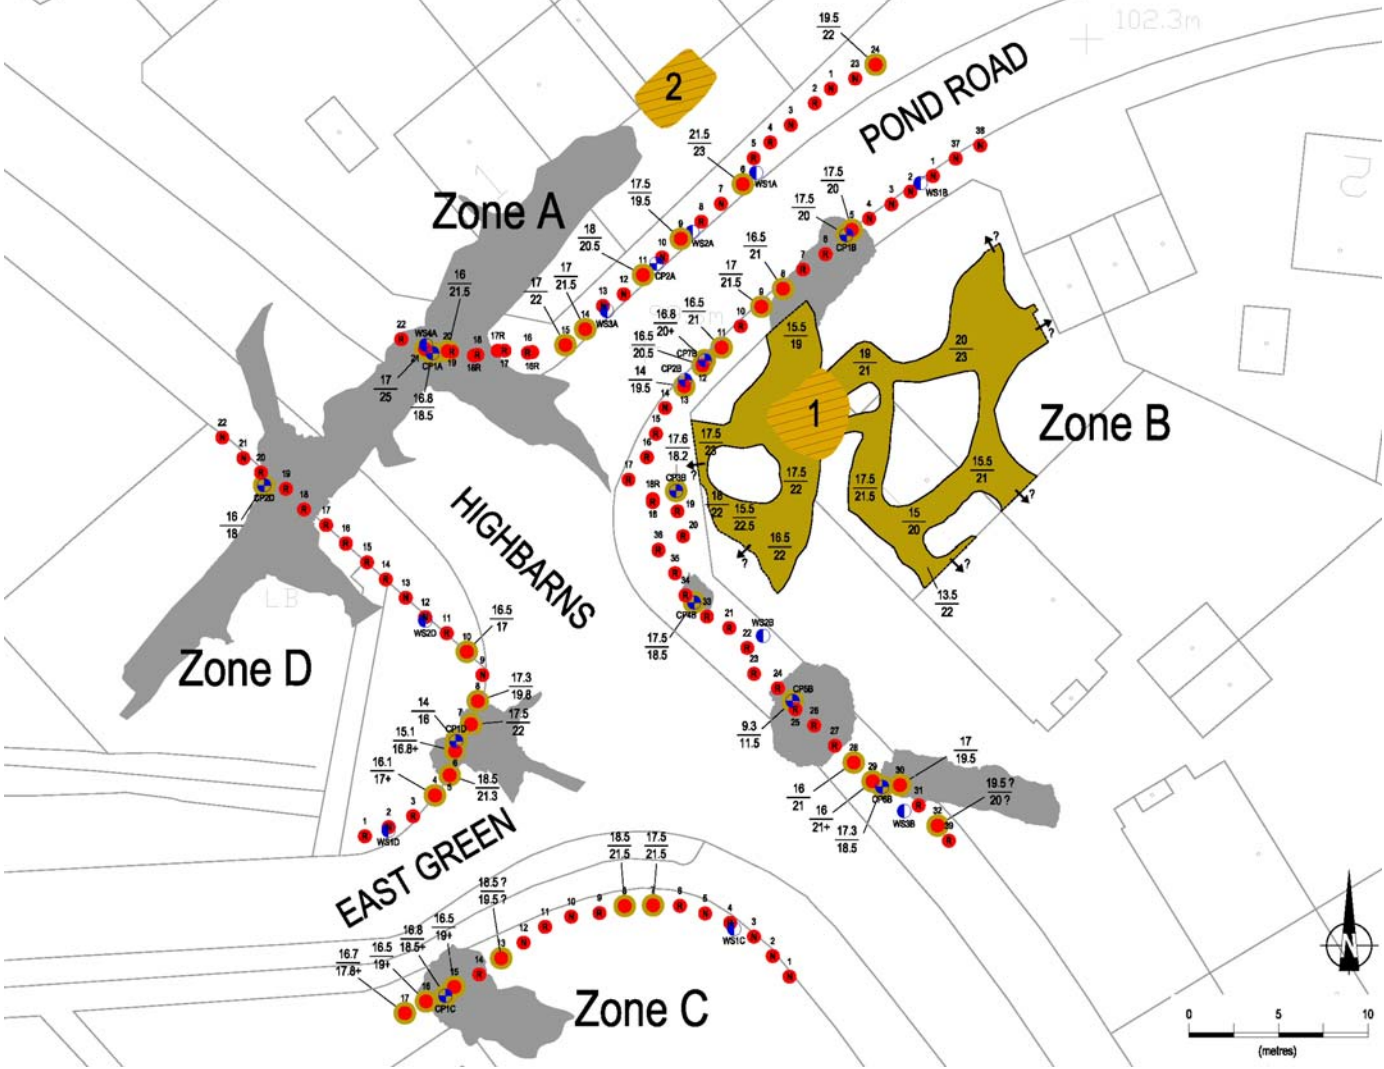
## COMBINED INTERPRETIVE PLAN OF MINE WORKINGS

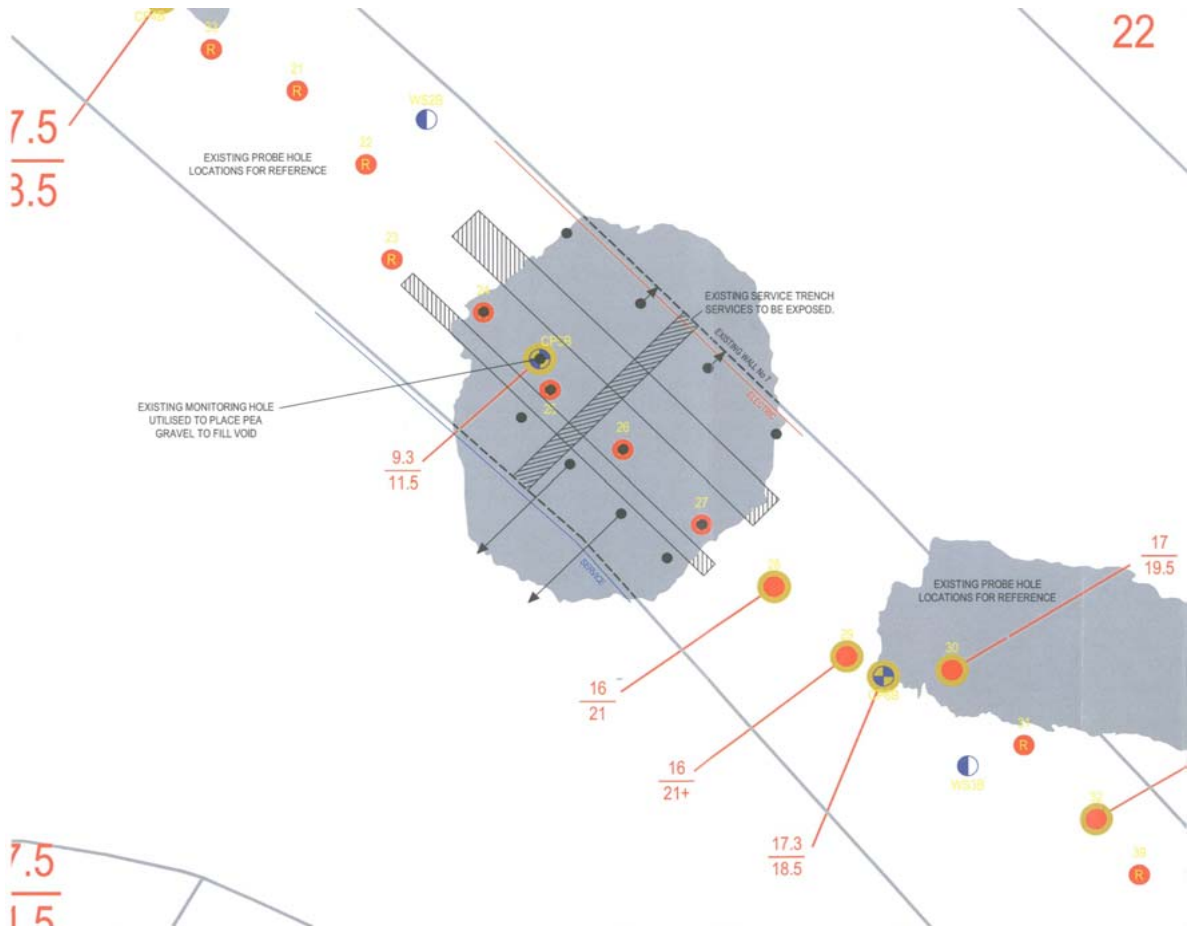
## REMEDIAL GROUTING WORKS AT CP5B

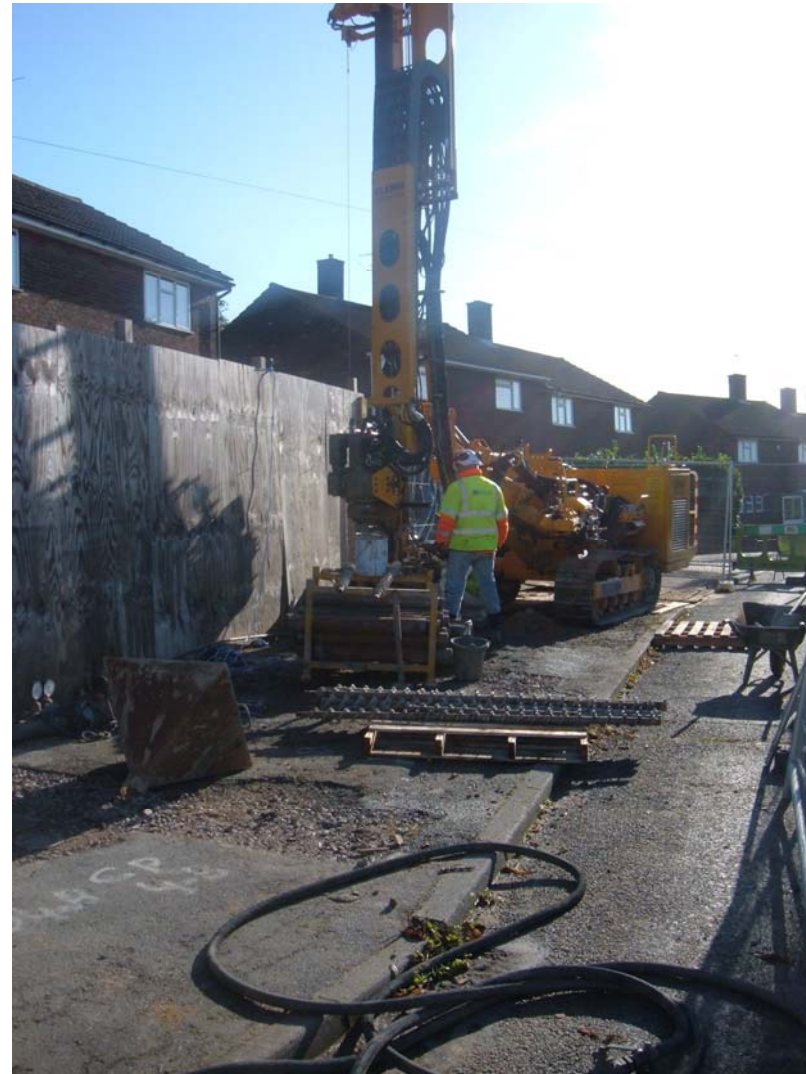
## REMEDIAL GROUTING WORKS AT CP5B

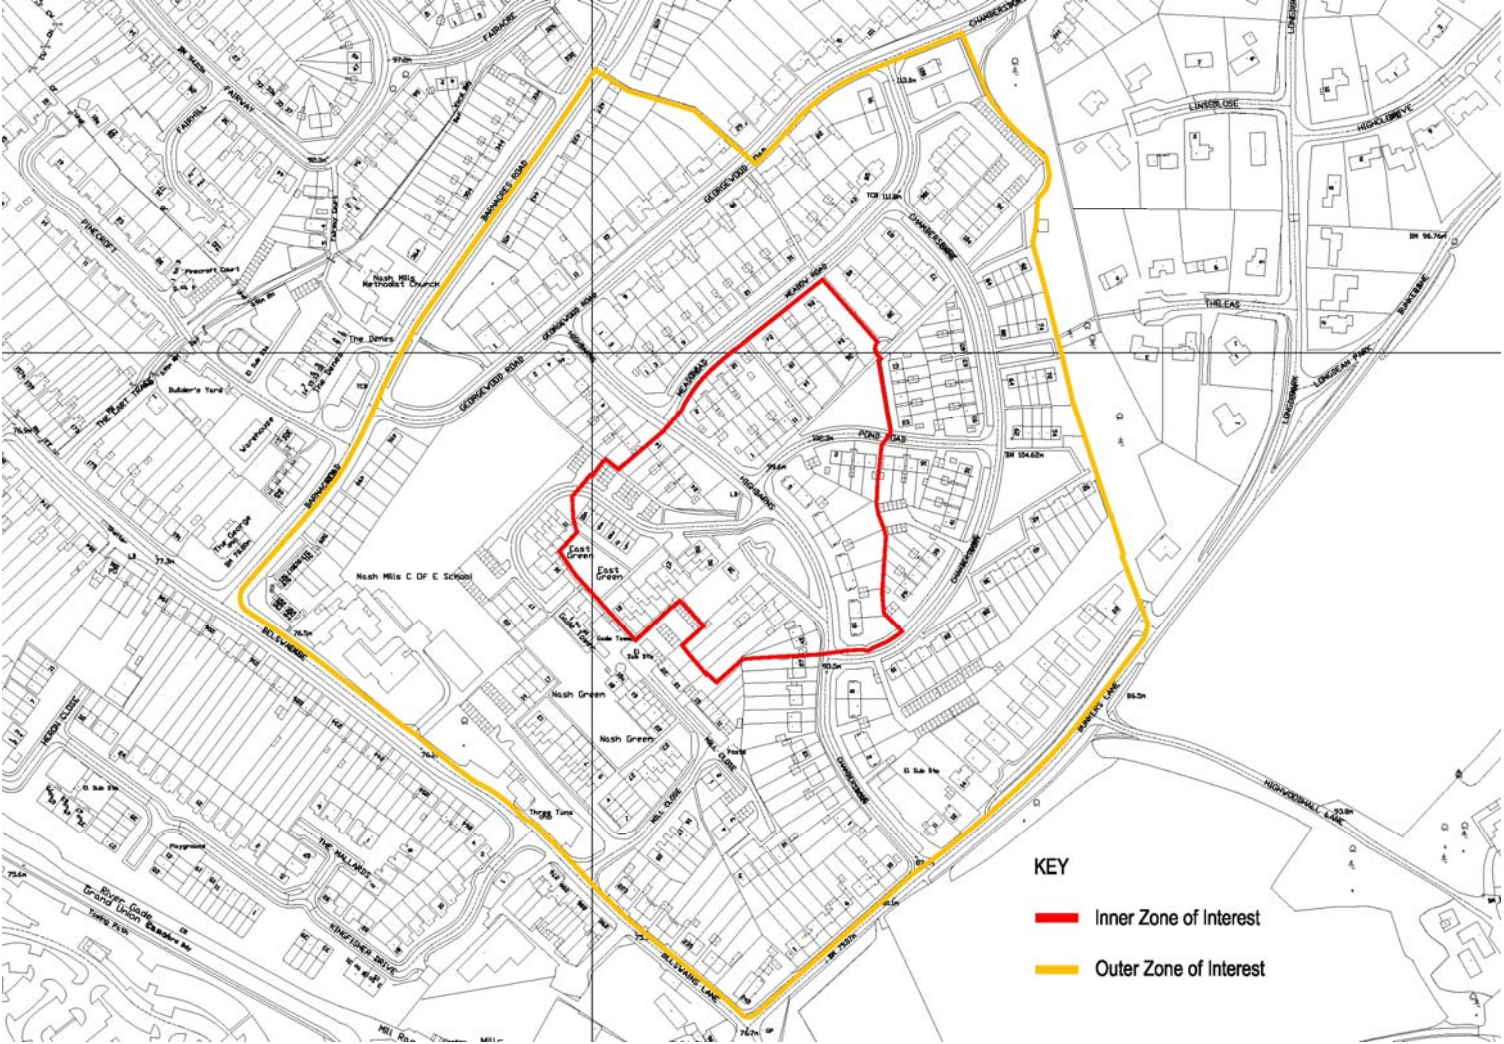
## PROPOSED GEOMORPHOLOGICAL MAPPING
