CHALK MINE STABILISATION PROJECT HIGHBARNNS, HEMEL HEMPSTEAD

Treatment Area 8: Nos. 28, 29 & 30 East Green

Report Number: 0013-UA000857-TR-01-TAR-0008

OCTOBER 2015

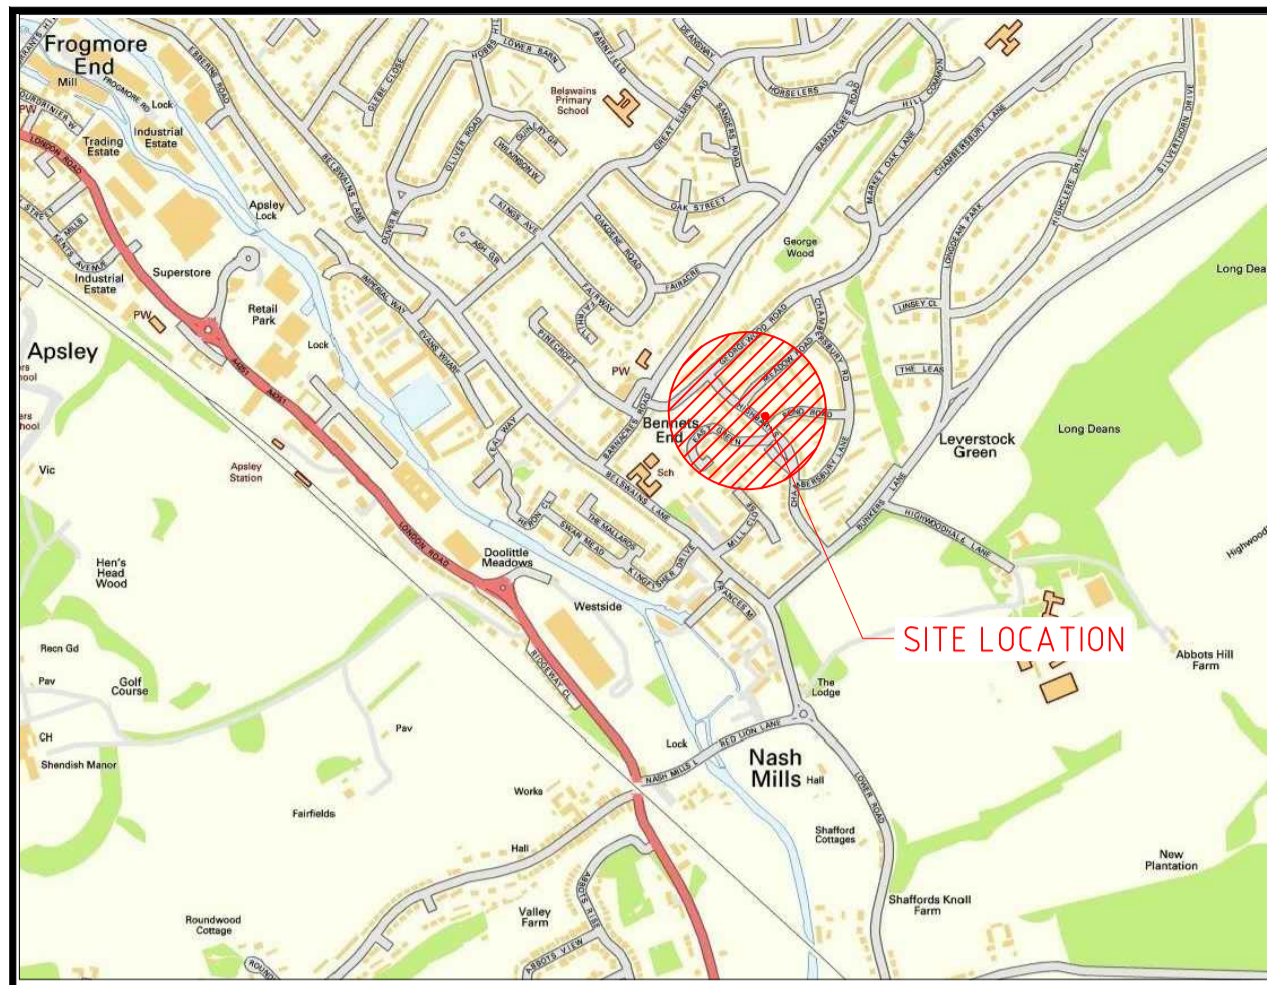
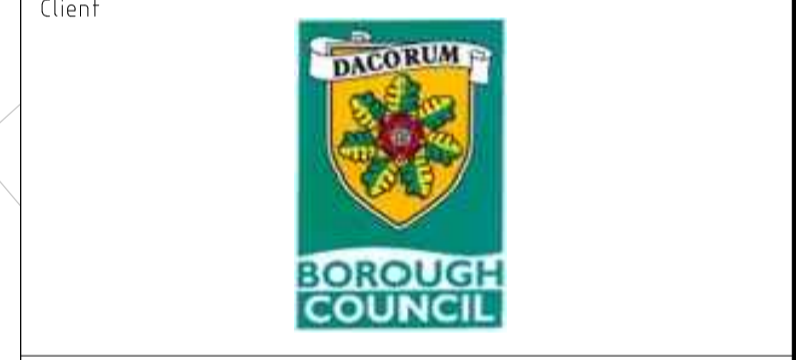
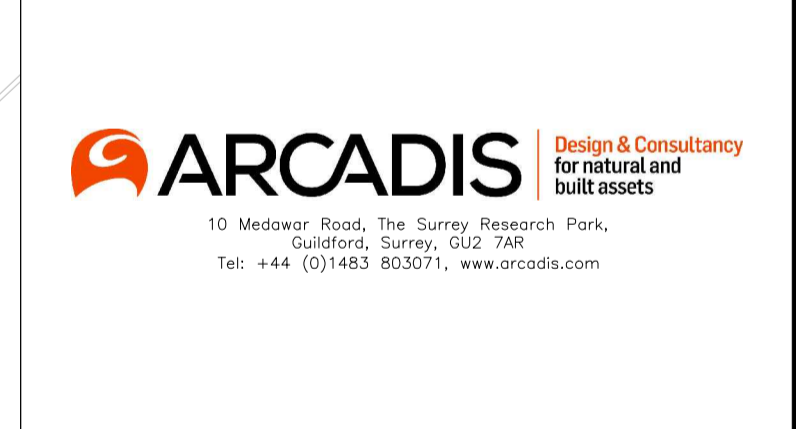
**Drawing TA08-01 – Treatment Area Plan for TAR0008
with Grout Holes**

Validation probing carried out along the front and back gardens following grouting works revealed more competent ground conditions than pre-treatment. A total volume of 56.2m³ of grout was injected into ten vertical and inclined compaction grout holes targeted at this property.

Vertical compaction grout holes carried out along the back garden resulted with high grout volumes at CGV399 (15.4m³) and CGV401 (43.4m³) suggestive of open mine workings at the mine junction. A gradual reduction in grout volumes was observed at the remaining treatment locations in the back garden. Further inclined grout holes were also undertaken beneath the property from the back garden. Following the initial high grout takes at CGI253 (20.1m³) and CGI254 (12.4m³), subsequent grout volumes were seen to reduce to site-wide average grout takes at CGI251 (3.1m³) and CGI252 (4.4m³).

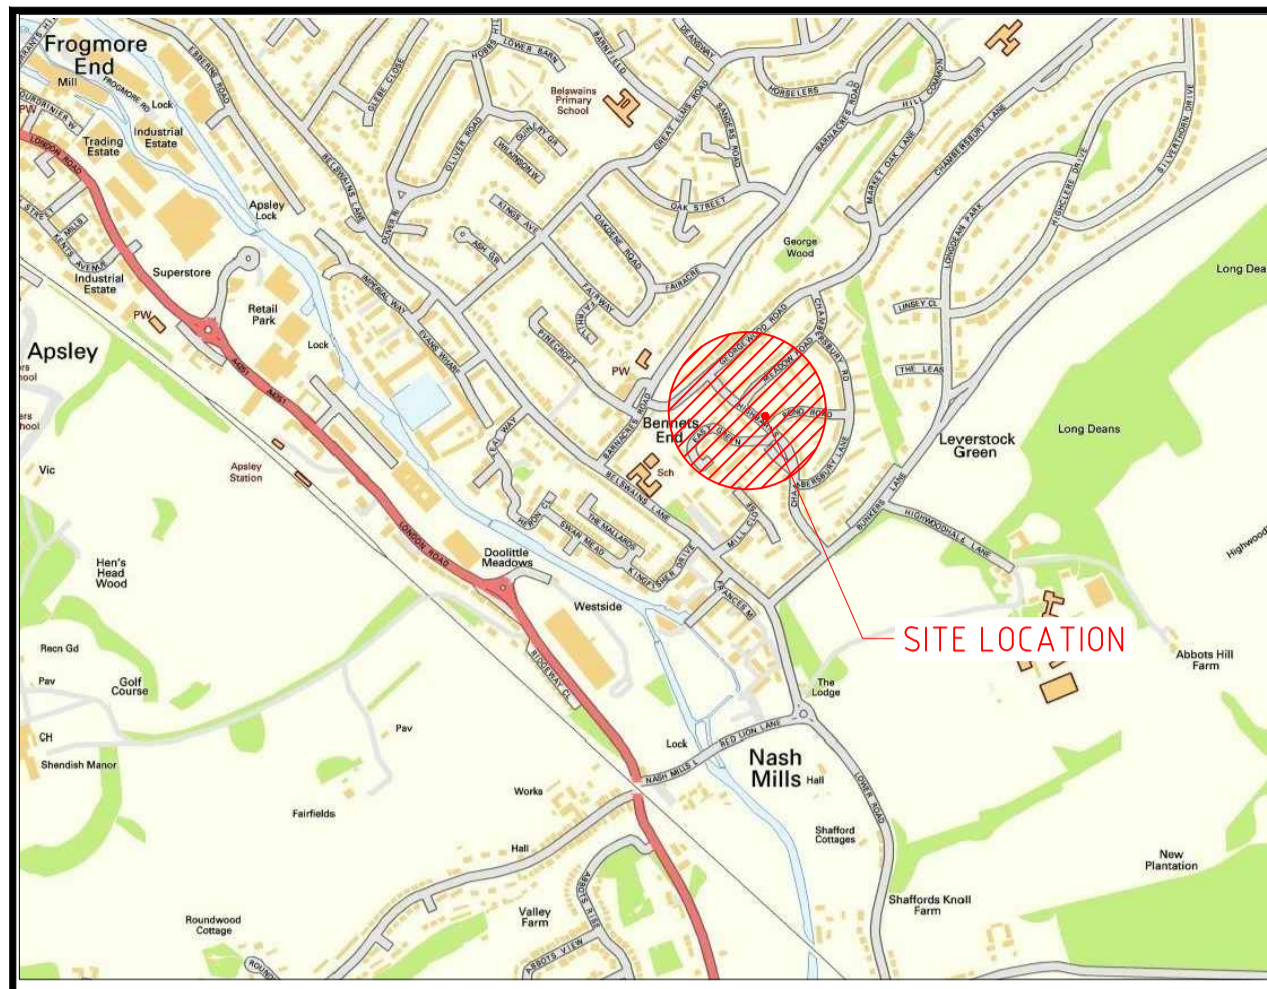
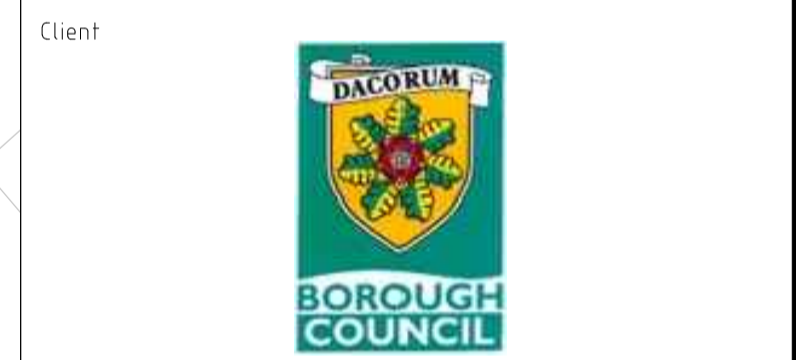
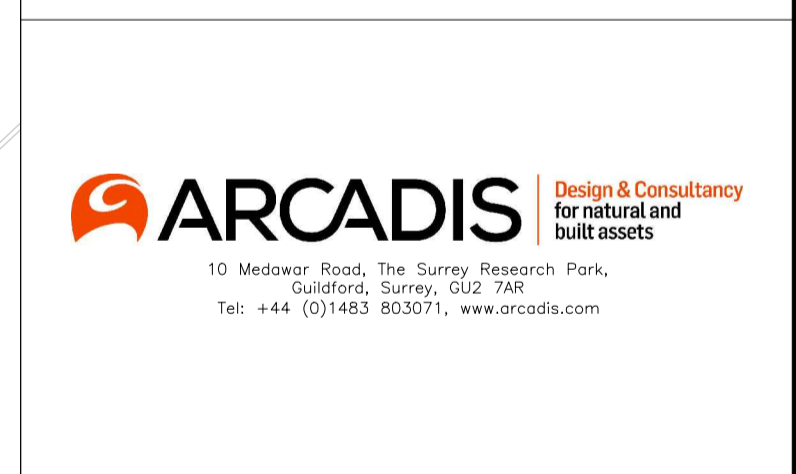
**Drawing TA08-02 – Treatment Area Plan for TAR0008
with Validation Probes**

The validation dynamic probe (VP229) carried out inside the building following treatment did not record any residual weaknesses in the chalk. Likewise validation probing carried out in front of the property with VP179 revealed competent ground conditions following treatment.
